Manhole Inspection Summary

Manhole # S43AA_068MH

Insp Date: **3/15/10 10:45 AM**

Location Address: **Madison Ave.**

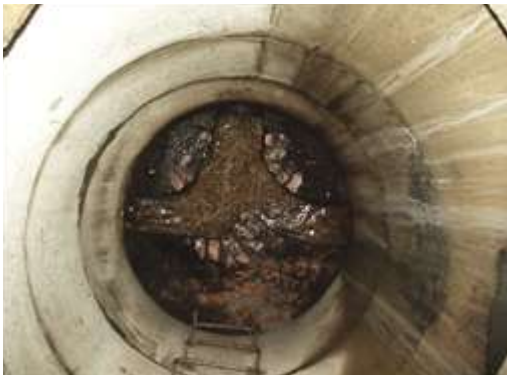
Top View

MH Cover was 30 inch storm sewer cover. Field crew replaced cover with sanitary sewer cover.

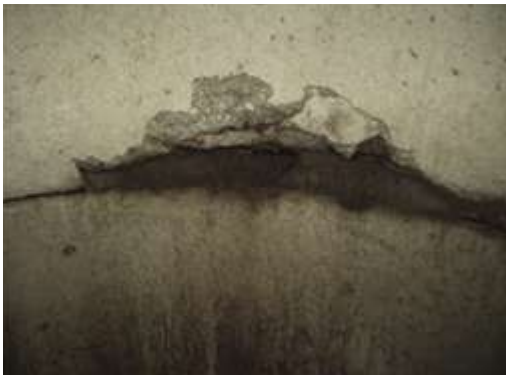
Defect 2

Condition: ☐ Sound ☒ **Cracked** ☐ Root Intrusion ☐ Loose Brick ☐ Deteriorated

cracks

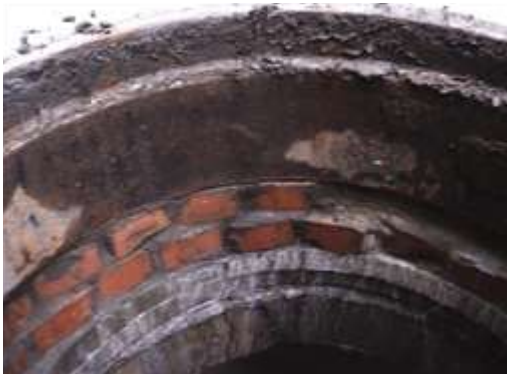
Defect 1

☒ **Leaks**

frame leaks

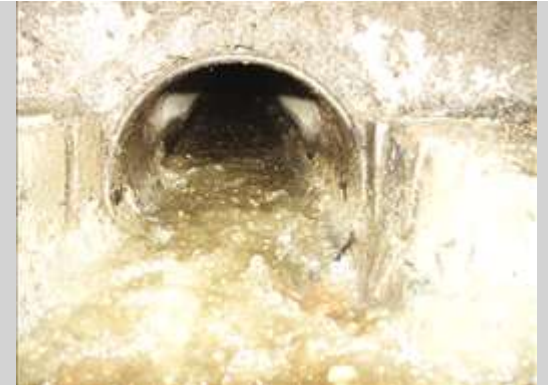
12 O'Clock Outflow

10 in. Circular Gravity Sewer
Pipe Out @ 12 O'Clock

Pipe Height: **14.4** (in.) Rod and Bar (Angled)
Pipe Material: **Clay** ☐ Pipe Lined
Invert Depth: **11.67** (ft.) Flow Characteristics: **Fast**
Deposits: ☒ None ☐ Mud ☐ Sludge ☐ Debris ☐ Grease
Silt Depth: (in.) Deposits Extent:
Infiltration: **None** Pipe Seal Cond: **Sound**

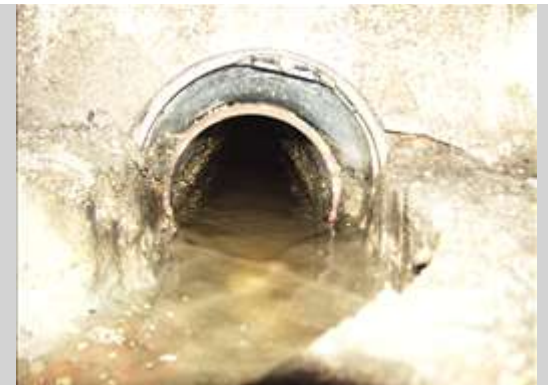
3 O'Clock Inflow

8 in. Circular Gravity Sewer
Pipe In @ 3 O'Clock

Pipe Height: **12** (in.) Rod and Bar (Angled)
Pipe Material: **Clay** ☐ Pipe Lined
Invert Depth: **11.33** (ft.) Flow Characteristics: **Slow**
Deposits: ☒ None ☐ Mud ☐ Sludge ☐ Debris ☐ Grease
Silt Depth: (in.) Deposits Extent:
Infiltration: **None** Pipe Seal Cond: **Sound**

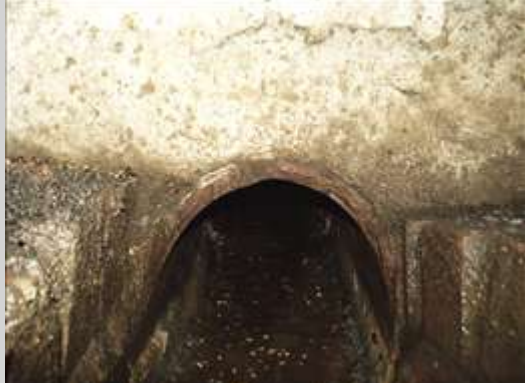
9 O'Clock Inflow

8 in. Circular Gravity Sewer

Pipe In @ 9 O'Clock

Infiltration: **None** Pipe Seal Cond: **Sound**
